SYSTEMS REPORT

SOLAR APARTMENT BUILDING

AYLMER, ONTARIO

August 1982

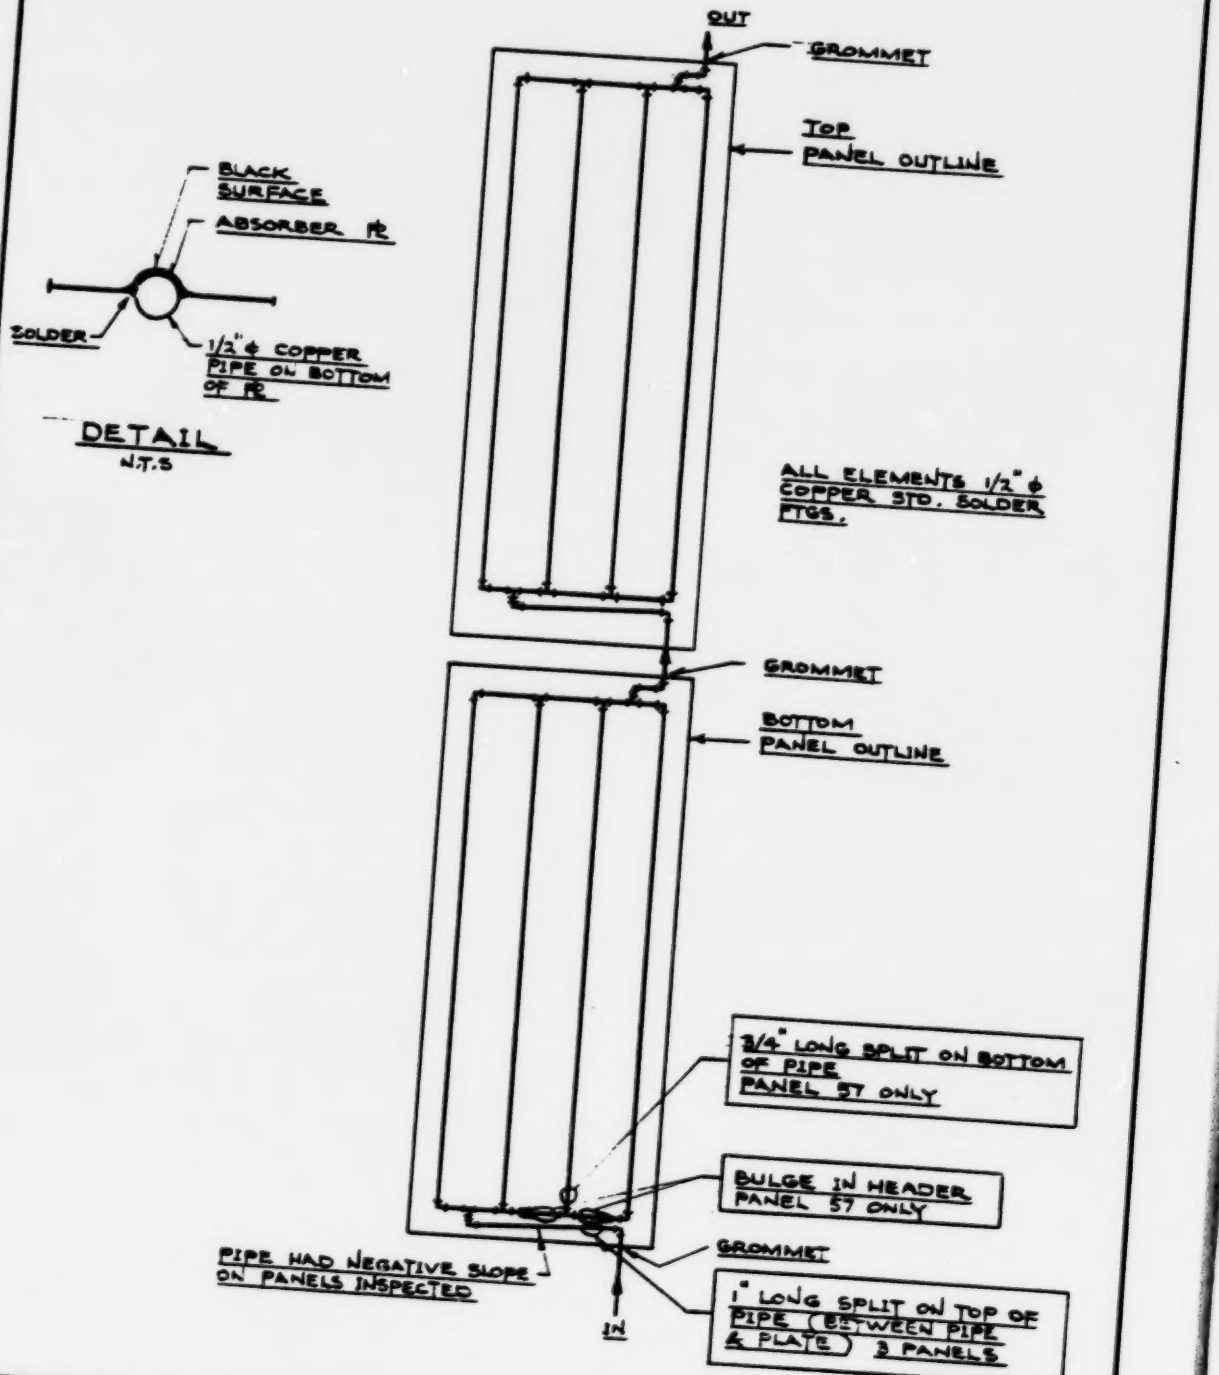
DILLON Consulting Engineers & Planners	TITLE TYPICAL COLLECTOR PANEL ARRANGEMENT	PROJECT NO. 8765-03-X01
DATE AUG. 20, 1982	PROJECT AYLMER SOLAR HEATING SYSTEM	DETAIL NO. APPENDIX 'D'

.3 Loss of storage tank water in the middle of January 1982 was investigated and it was found that four collector panels in the lower row were leaking badly. The collector pump was shut down from the 20th January until 2nd April after isolating valves had been installed on the leaking panels. In July 1982, the four leaking panels were removed and replaced with three which were in stock at the site, and one new one supplied by the manufacturer. An inspection of the damaged panels showed that the copper piping in the panels had split. In three panels, the split was in the bottom connecting piping below the bottom header and in one the split was in one of the vertical collector tubes just above the bottom

header. The damage had obviously been caused by water freezing in the tubes.

It was noted that the horizontal part of the connecting pipe from the lower header in the panels inspected, had a negative slope so that water could be trapped in this section. The pipe was originally horizontal but as it was free at one end, it could be pushed up during installation, resulting in a negative slope for draining. Appendix "D" is a sketch showing a typical collector arrangement. It was probable that some water could be trapped which would freeze under extreme climatic conditions. The fact that the lower collectors only were affected, could be explained by the probability that there would be a siphon effect resulting from the drainage of the lower collectors. It is believed that the damage occurred on the 17 January. The meteorological station at London reported the following for 16-17-18 January 1982:

collector pipes. As there may be other collectors with a similar defect in the lower connection pipe, it would be wise to manually switch off the collector pumps under similar severe weather conditions. The amount of collected heat involved would be negligible.
